A Full-Scale Fatigue Test of 9-m CX-100 Wind Turbine Blades

G. PARK, K. M. FARINHOLT, S. G. TAYLOR and C. R. FARRAR

This paper presents the SHM result of a 9m CX-100 wind turbine blade under full-scale fatigue loads. The test was performed at the National Renewable Energy Laboratory. The 9-meter blade was instrumented with piezoelectric transducers, accelerometers, acoustic emission sensors, and foil strain gauges on the surface of the blade. The blade underwent fatigue excitation at 1.8 Hz for defined intervals, and data from the sensors were collected between and during fatigue loading sessions. The data were measured at multi-scale, high frequency ranges for identifying fatigue damage initiation, and low-frequency ranges for assessing damage progression. High and Low frequency response functions, time series based methods, and Lamb wave data measured by piezoelectric transducers were utilized to analyze the condition of the turbine blade, along with other sensing systems (acoustic emission). A specially designed hardware developed by Los Alamos National Laboratory was also implemented for performance comparison. This paper summarizes considerations needed to design such SHM sy

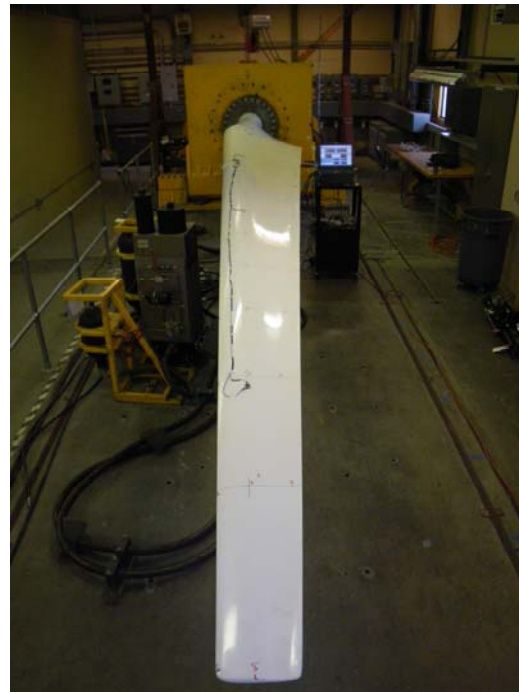
Figure 1. Test setup: a 9m CX-100 blade under a fixed-free condition

The test structure of a 9-m CX-100 blade [1] is shown in Figure 1. The blade was mounted to a specially designed massive metal frame in a way to simulate a fixed-free condition. First, a roving hammer test was used, employing three shear accelerometers (PCB 352C22) and four piezoelectric transducers (APC, a half inch diameter) and a modal impact hammer (PCB 086D20). The impact hammer tip was selected to excite up to 150Hz, which contains the first several modes. The blade was impacted at several points along the length and chord of the blade in the both flap-wise and edge-wise direction. A total of 4096 time domain data was measured at each time frame with the sampling frequency of 320 Hz. 5 averages were made for frequency response estimation with no window used.

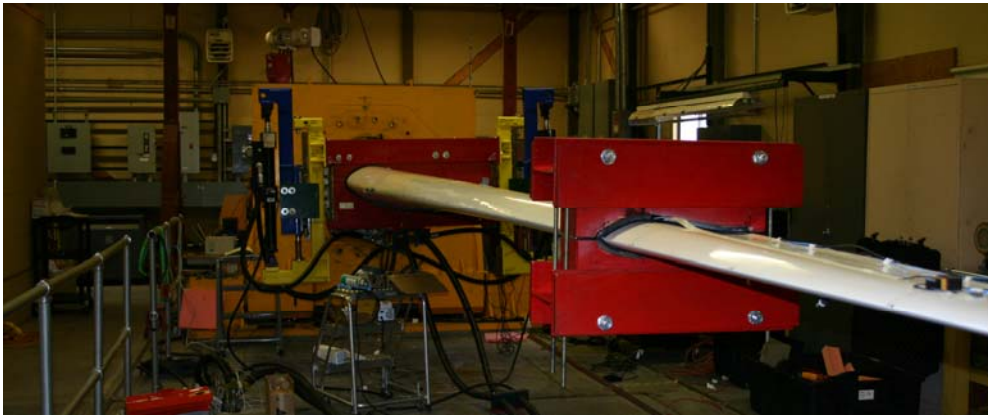
Figure 3: Experimental setup after adding two weights

be seen, the piezoelectric transducers identify the resonant frequencies of a structure with the same accuracy provided by an accelerometer. After the modal test, two saddles were added to the structure to provide a higher fatigue load, which shows in the figure 3. This change in the structural condition significantly modifies the resonant frequencies as shown in the table 1.
